FINAL Remedial Investigation Report

Libby, Montana

Operable Unit 5 Libby Asbestos National Priorities List Site

HDR Engineering, Inc.

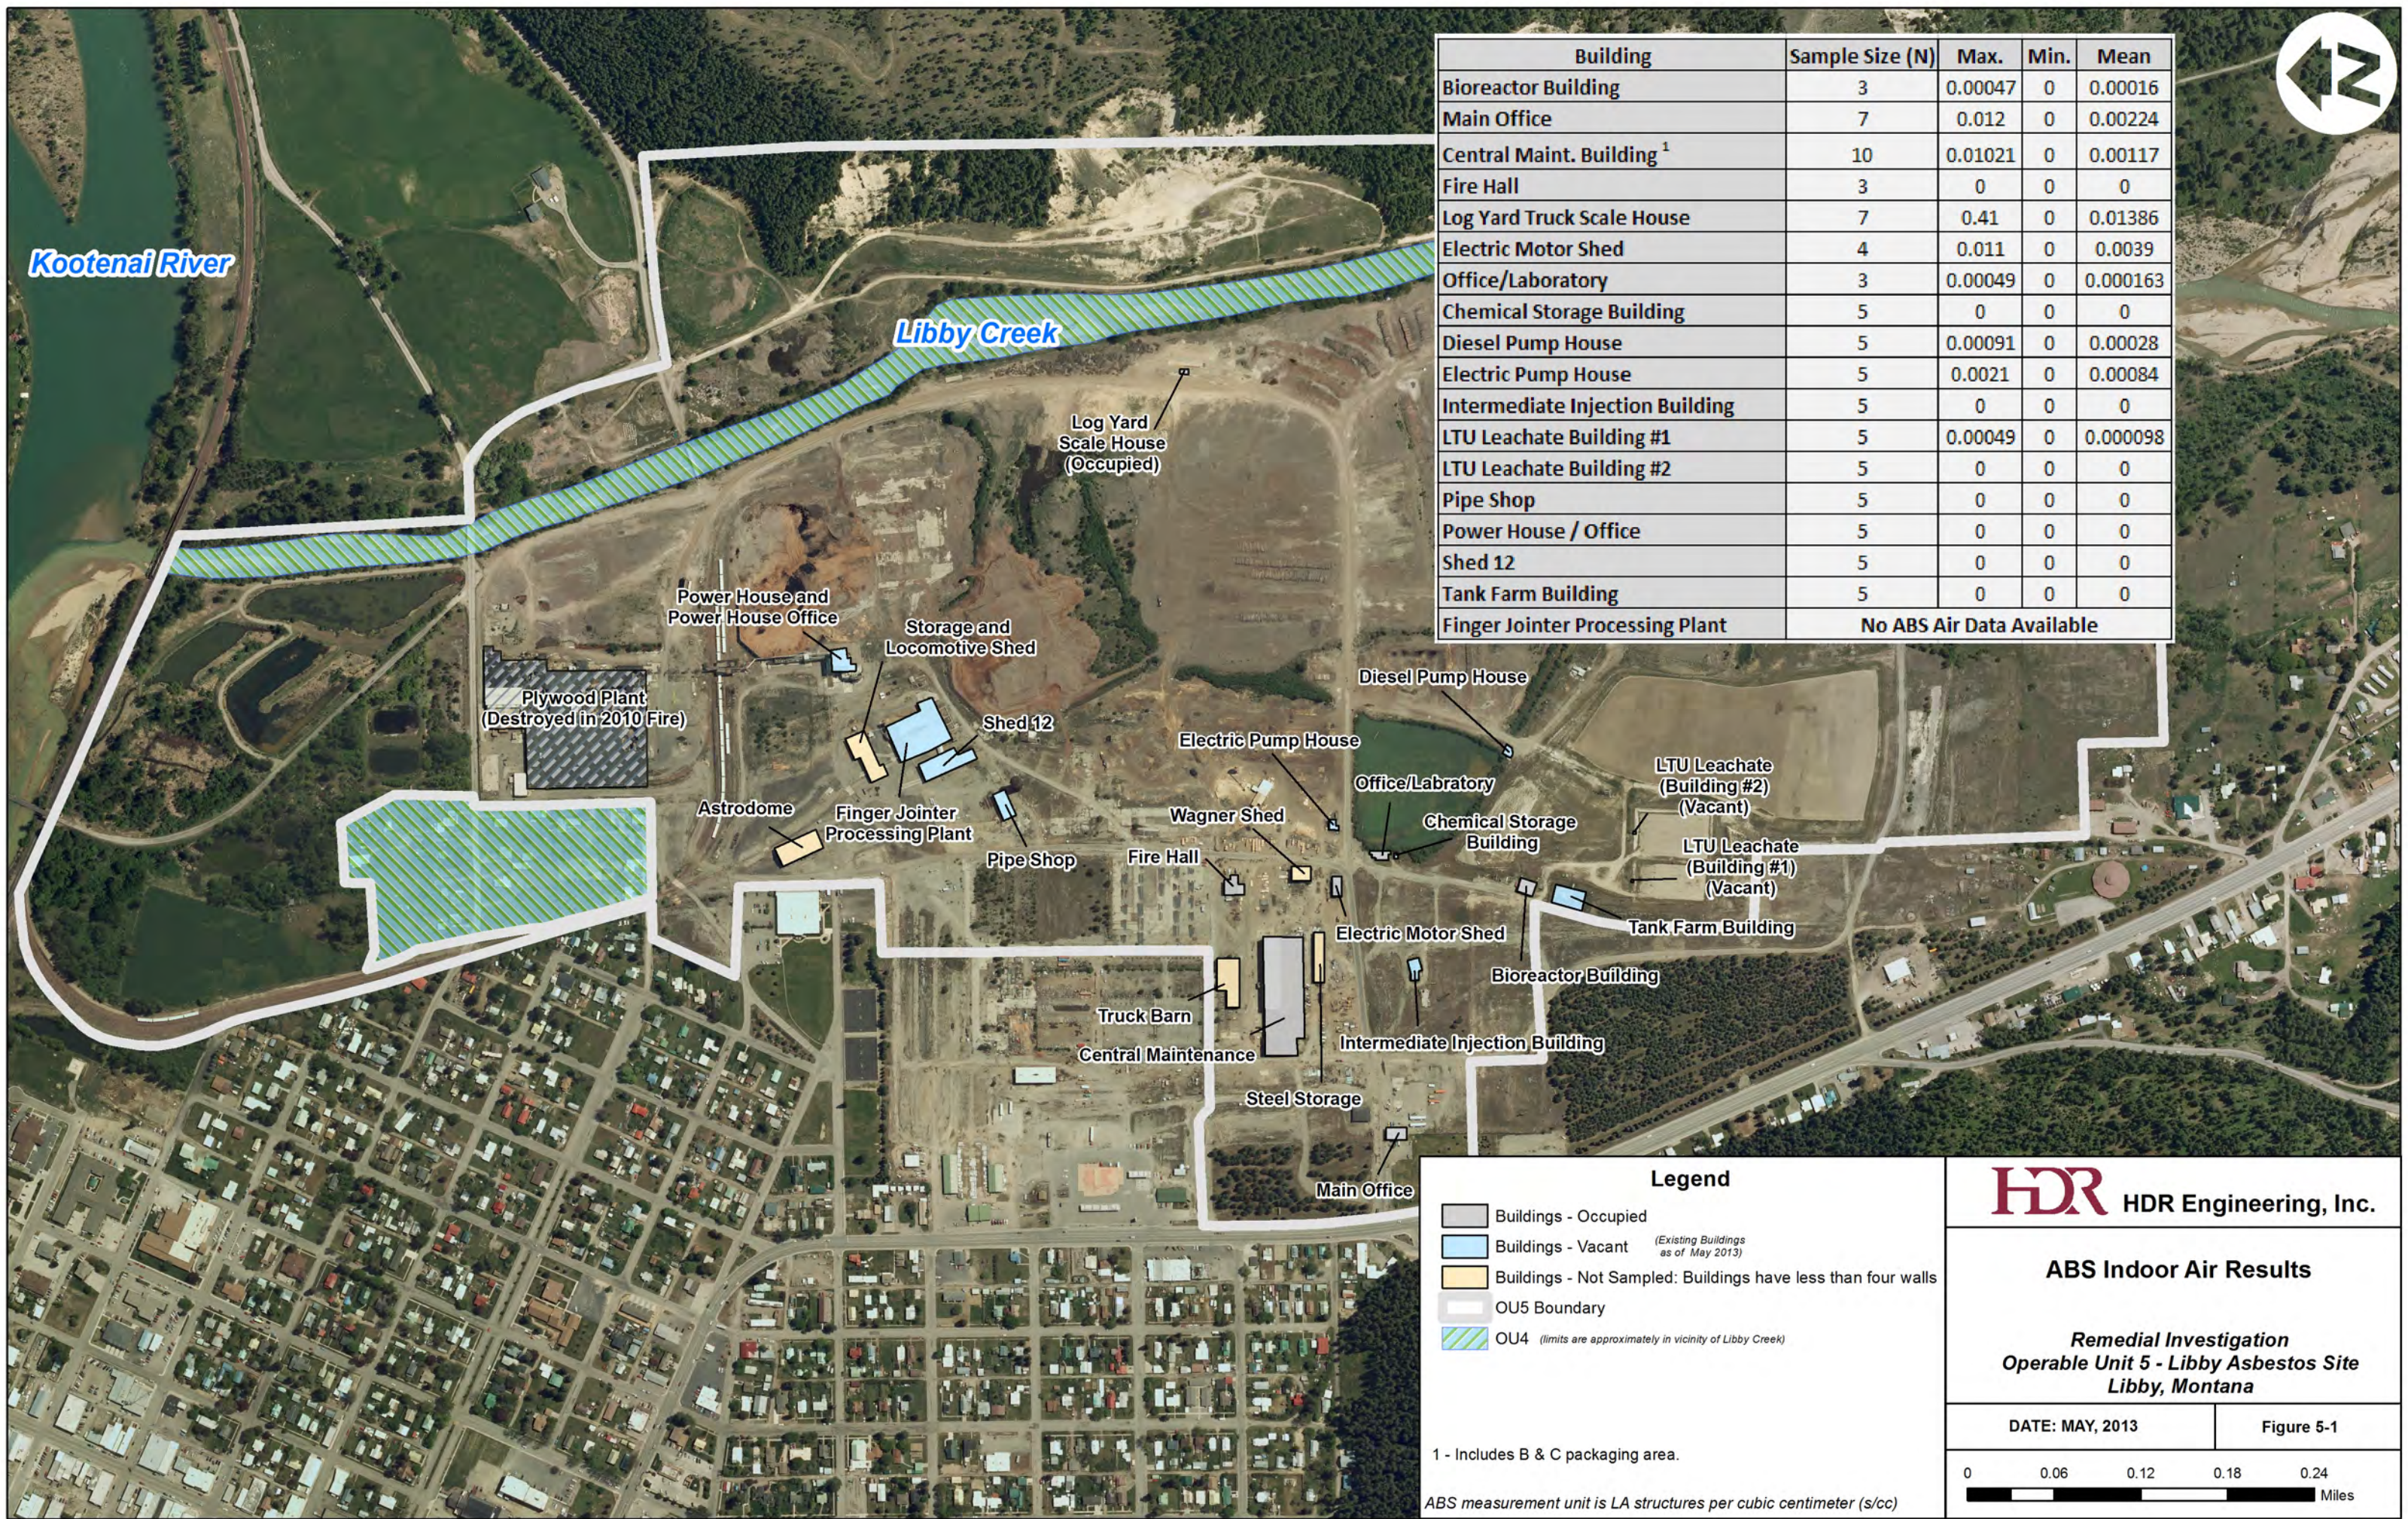
Building	Sample Size (N)	Max.	Min.	Mean
Bioreactor Building	3	0.00047	0	0.00016
Main Office	7	0.012	0	0.00224
Central Maint. Building ¹	10	0.01021	0	0.00117
Fire Hall	3	0	0	0
Log Yard Truck Scale House	7	0.41	0	0.01386
Electric Motor Shed	4	0.011	0	0.0039
Office/Laboratory	3	0.00049	0	0.000163
Chemical Storage Building	5	0	0	0
Diesel Pump House	5	0.00091	0	0.00028
Electric Pump House	5	0.0021	0	0.00084
Intermediate Injection Building	5	0	0	0
LTU Leachate Building #1	5	0.00049	0	0.000098
LTU Leachate Building #2	5	0	0	0
Pipe Shop	5	0	0	0
Power House / Office	5	0	0	0
Shed 12	5	0	0	0
Tank Farm Building	5	0	0	0
Finger Jointer Processing Plant	No ABS Air Data Available

ABS measurement unit is LA structures per cubic centimeter (s/cc)

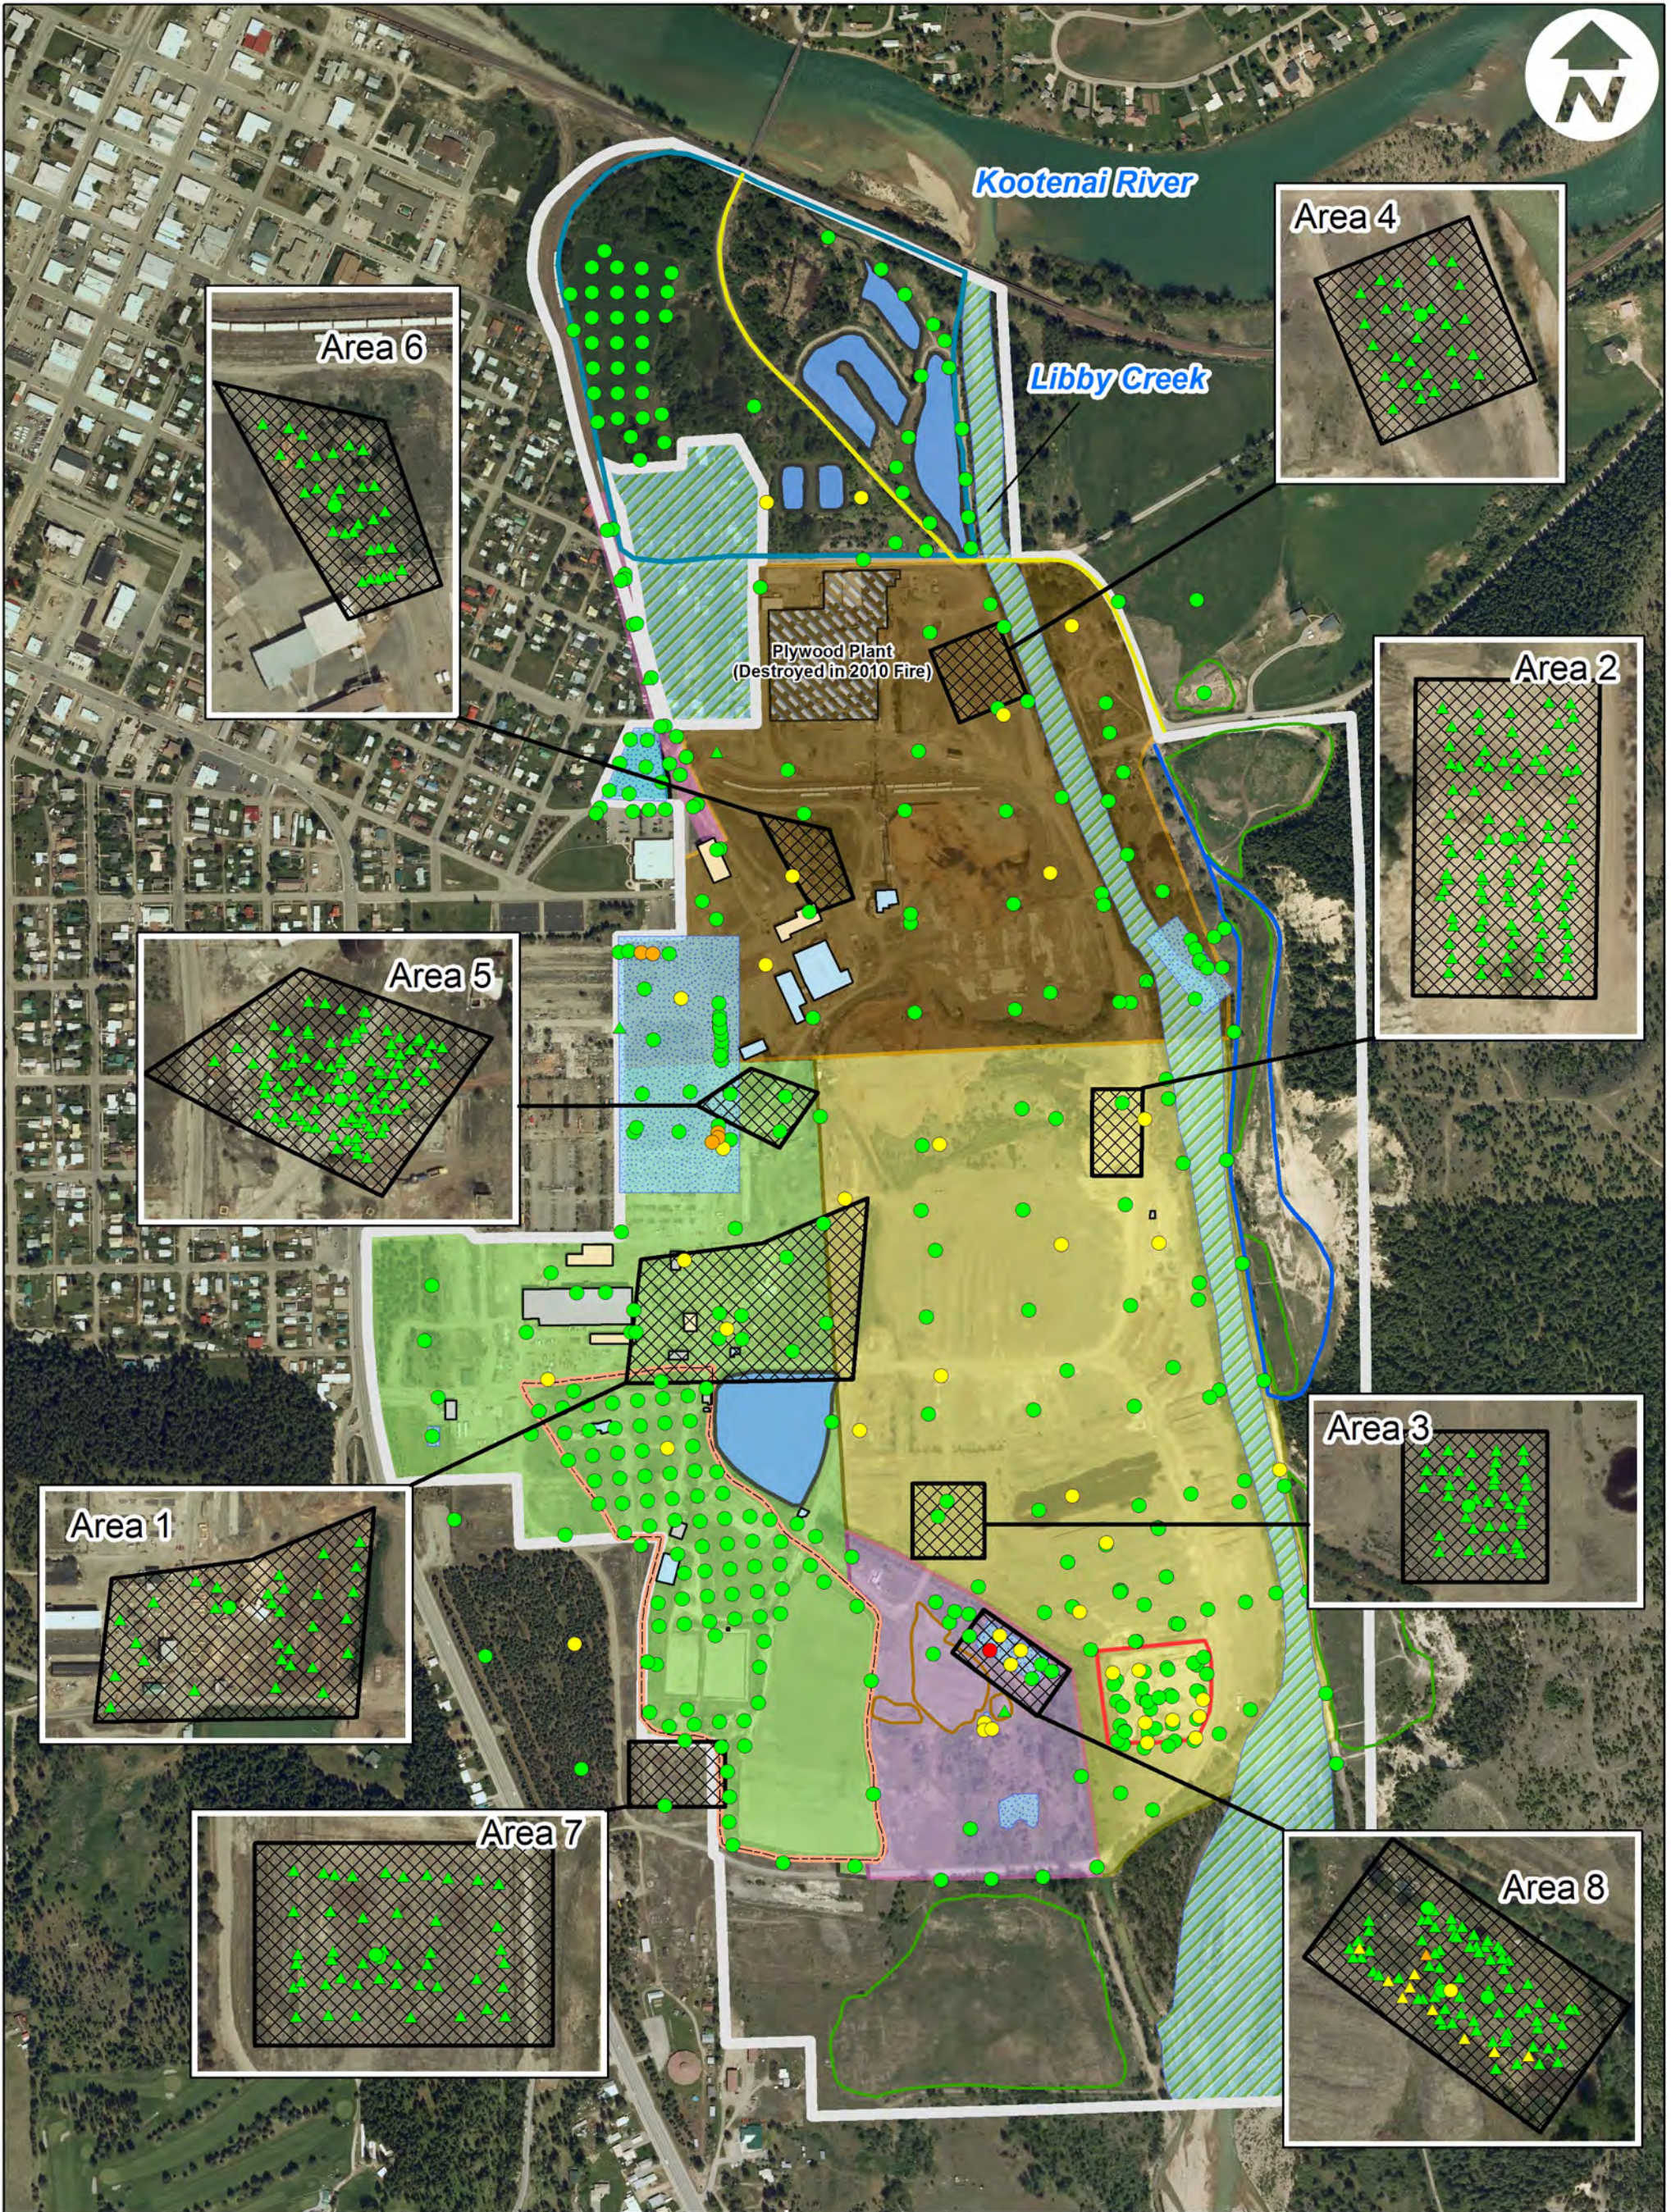
Figure 5-4

LA Results

Grab Samples

As shown in Figure 5-4, PLM results are generally non-detect or trace across OU5. The one location where PLM results have consistently been higher (with observed LA levels up to 1%) is the north-central portion of the former Tree Nursery area. This location also has elevated visible scores (see Figure 5-5).

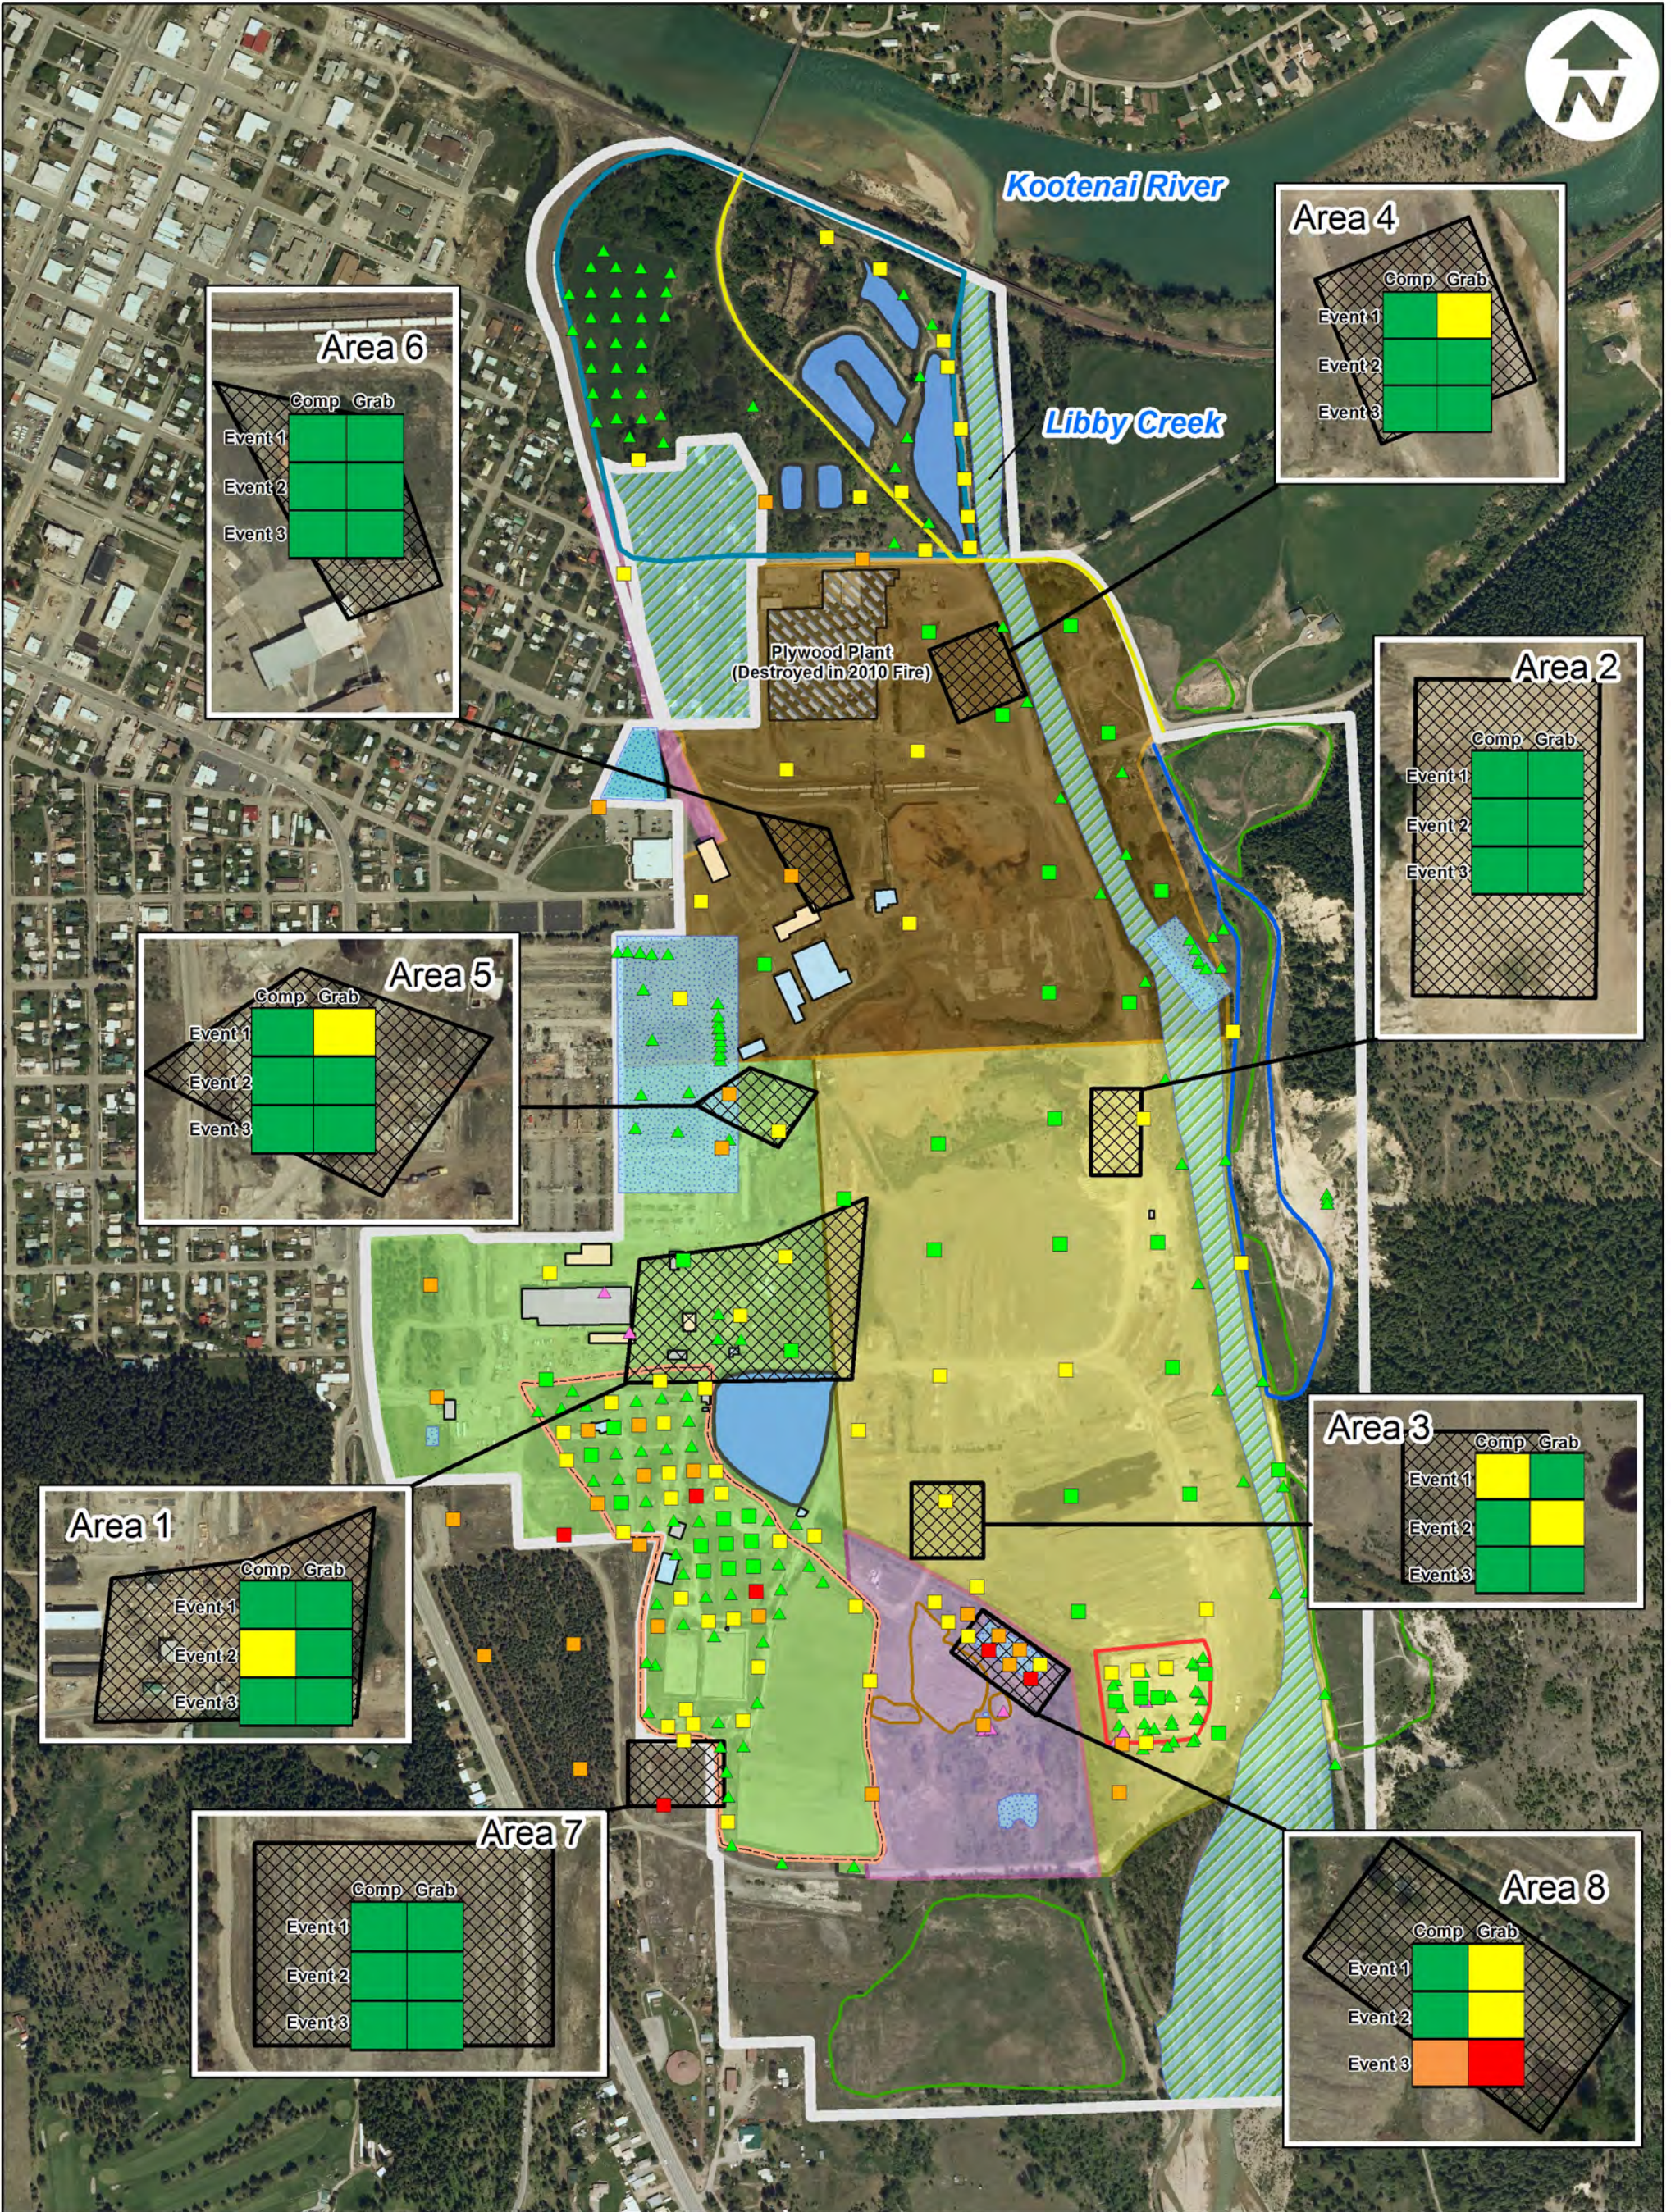
Visible Vermiculite Results

Composite Score

¹Results shown on Figure reflect testing done before abatement actions. See Figure 1-4 & Table 1-1 for details on response actions taken at OU5.

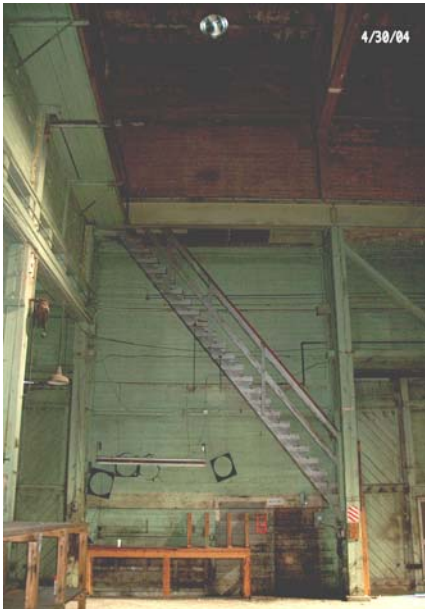
North side bay 13, note obstacles to work area. The stairway accesses the catwalk on the west side of the Former Mobile Shop.

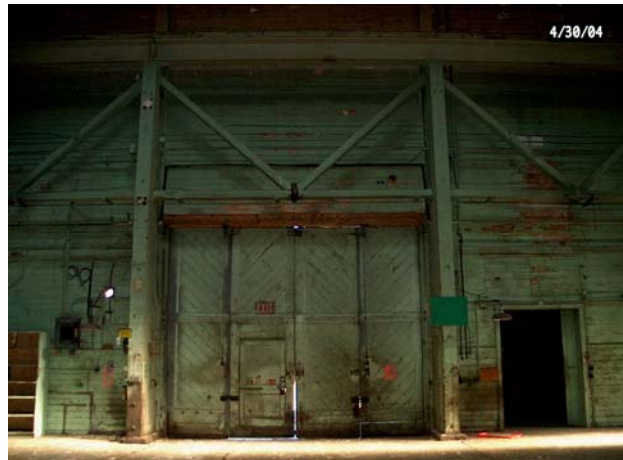
North side bays 11, 10, 9 from left to right. A door and solid wall are at lower section of bay 10, Wall cavities with VCI are in all of bays 9 and 11. Trusses for crane track in front of all wall bays.

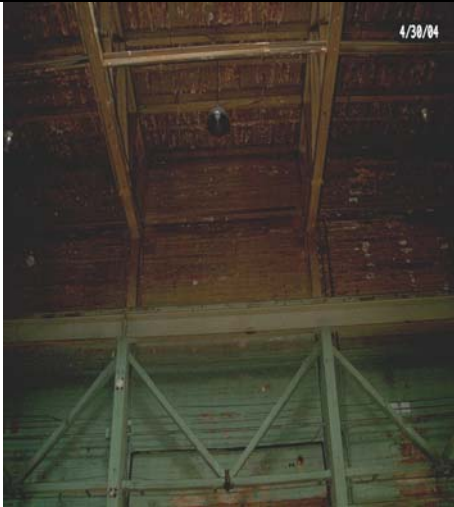
Typical upper section of bays. Note steel beam and trusses along north and south side, this feature is for the 35 ton crane stationed on the east side of shop. VCI has settled onto many of the horizontal surfaces.

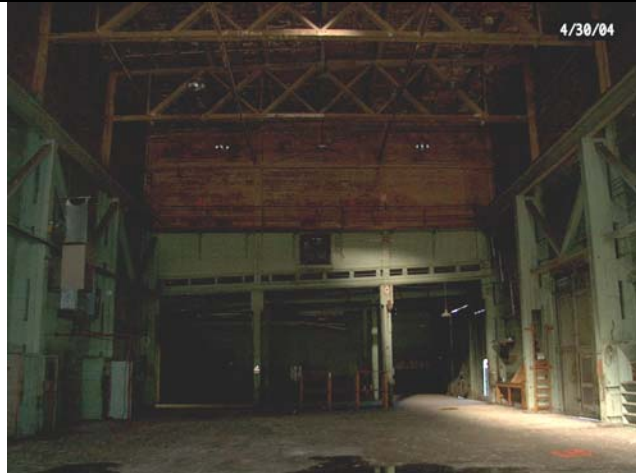
West wall of the Former Mobile Shop. The catwalk is located where the color changes from green to brown. Steel bracing is at the ceiling in northeast and southeast corners, but is not visible in this photo.

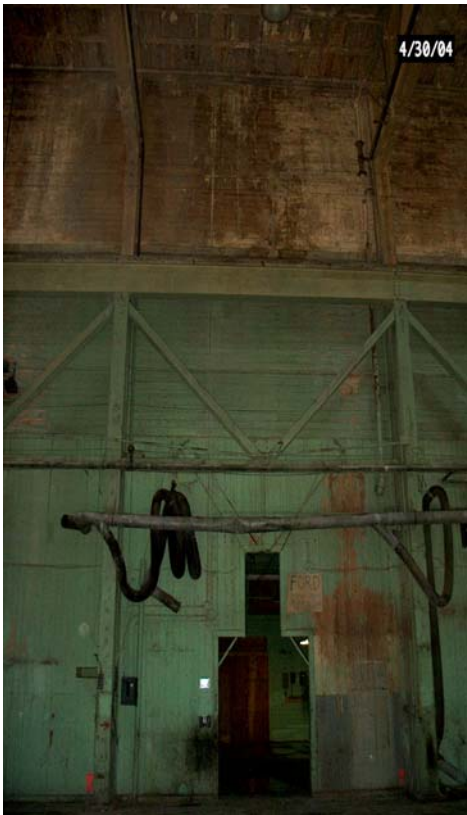
Typical south bays, photo shows bays 8 and 9. The lower 19 ft. wall sections are solid in all south bays.

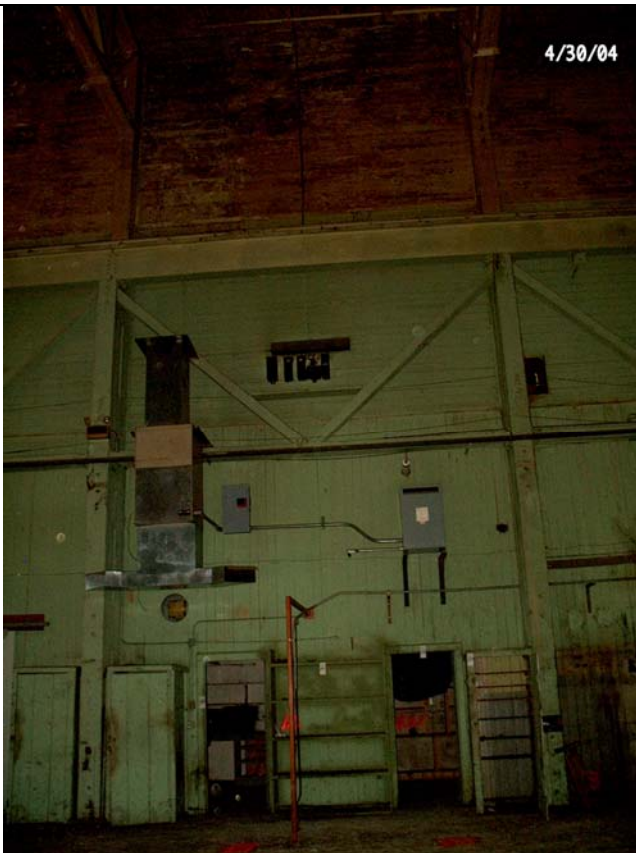
South side bay 12, showing some of the typical obstacles, penetrations, and utilities in the work areas.

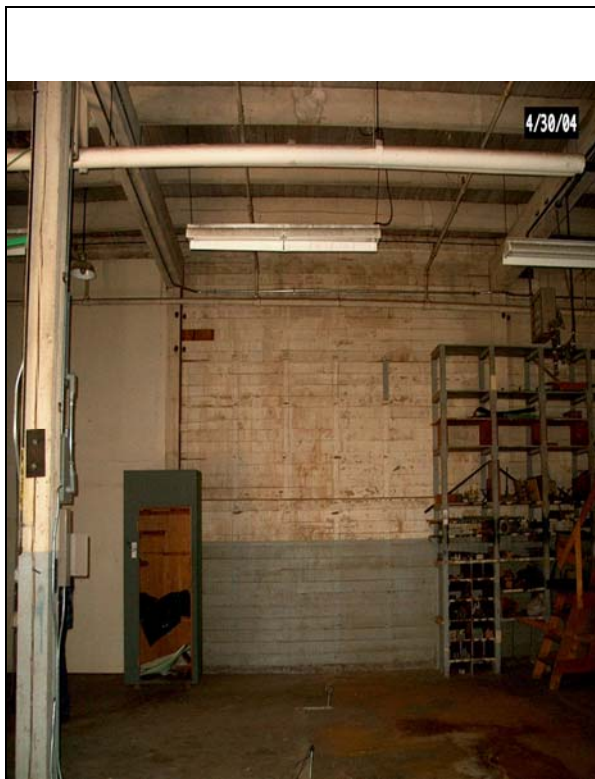
Room 1-1 (Fig 1). Midline wall. Walls in this room are accessible from a stepladder. These walls may contain full or remnant VCI.

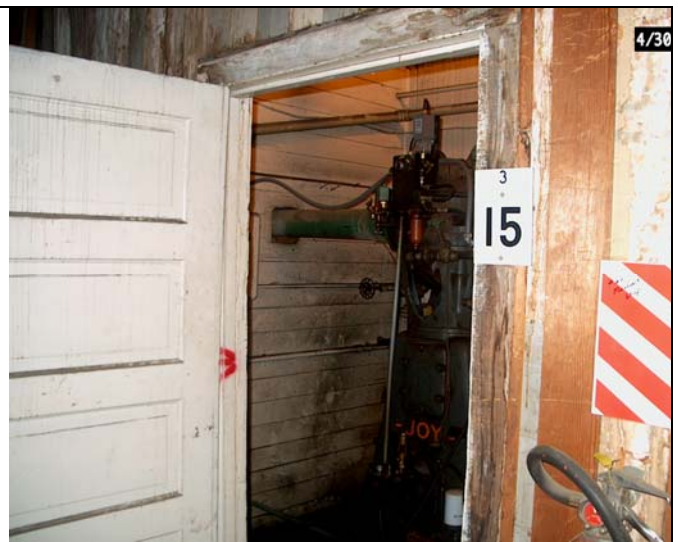
Room 17-2. These walls have full or remnant VCI, and are in a small room with a fixed furnace.

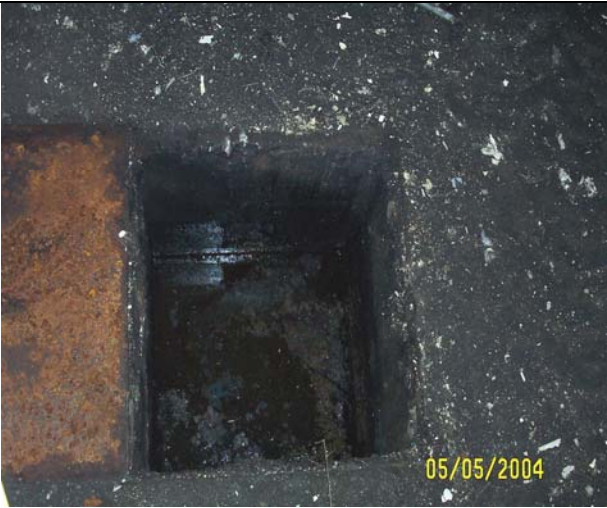
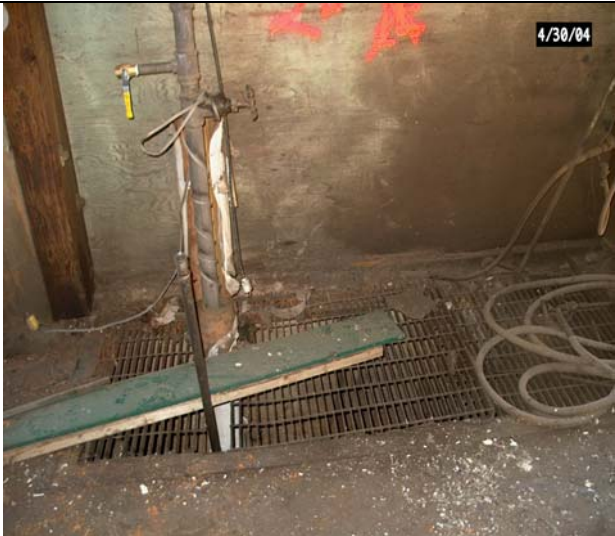
<p>Some vaults have water/sludge and do not require cleaning.</p>	<p>This pit is dry and has some debris, requires cleaning by disposing of debris and vacuuming pit. This is at the middle of east wall.</p>

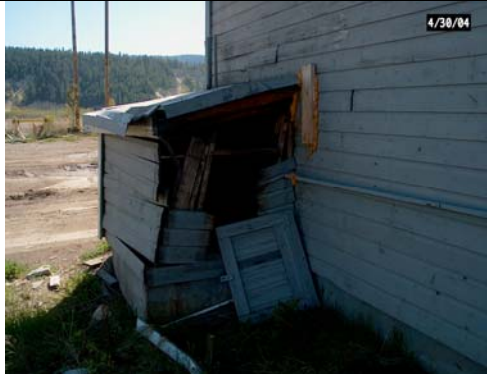
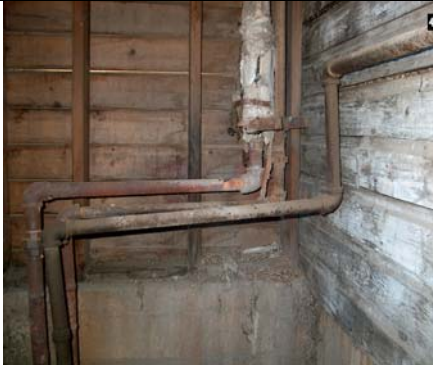
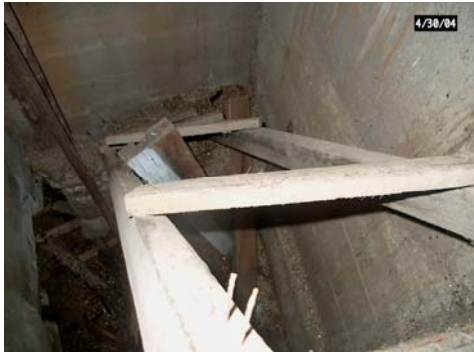
<p>The shack is located on the east end of the north side of the Former Mobile Shop (refer to Fig 2), and has VCI inside and on the ground outside. The shack will be dismantled and discarded.</p>	<p>Inside the shack – piping with remains of suspect ACM insulation. The insulation will be discarded as ACM.</p>	<p>Looking into the vault – VCI is scattered throughout this area – discard all debris within this vault – wash down and surface vacuum interior, apply encapsulant.</p>

- The shack will be dismantled prior to entry to ensure the safety of workers.
- The shack materials will be properly disposed of as ACM.
- Piping inside the shack will be protected and supported, as necessary.
- All suspect ACM insulation from the pipes will be removed and properly disposed.
- The vault located in the floor of the shack will then be remediated. Confined space entry procedures may be applicable for entry into this vault. Any debris inside the vault will be discarded as ACM.
- VCI within the vault will be removed with vacuum methods.
- Encapsulant will then be applied to the walls, floor, and piping within the vault.

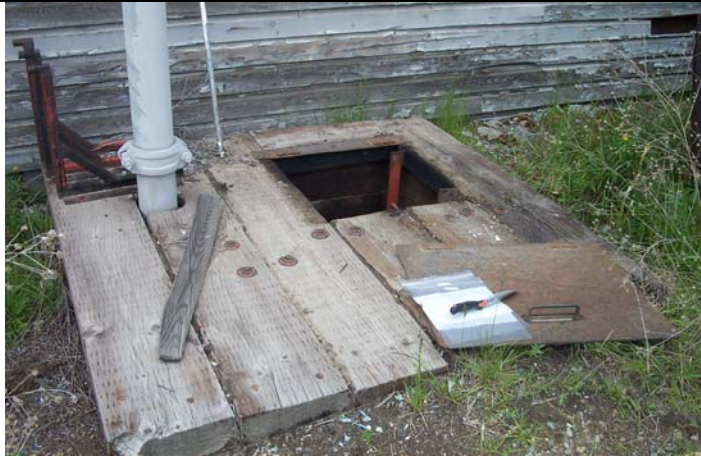
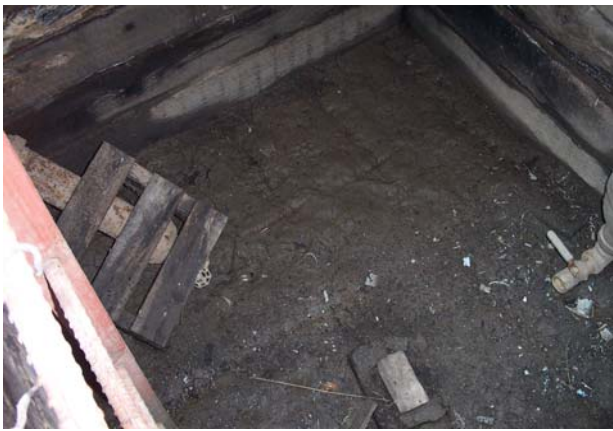
<p>Entrance to vault on the south east corner of the building. The Vault has creosote timber walls and a soil floor.</p>	<p>Floor of the vault as viewed from the entrance.</p>

- The vault on the southeast corner of building has vermiculite in the soil floor. However, soil samples reveal that LA asbestos is non-detect. Therefore, no remediation will be required to the soil floor of the vault.
- Any remnant VCI located on the surface of the soil floor will be vacuumed.
- Confined space entry procedures may be applicable for entry into this vault.

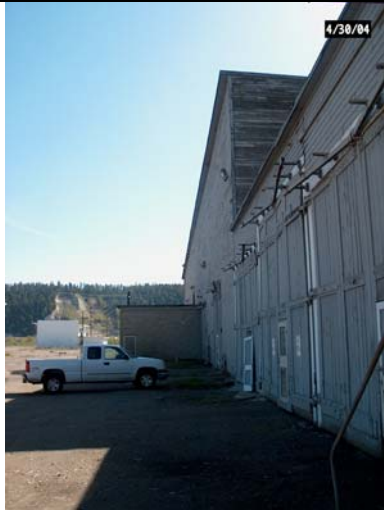
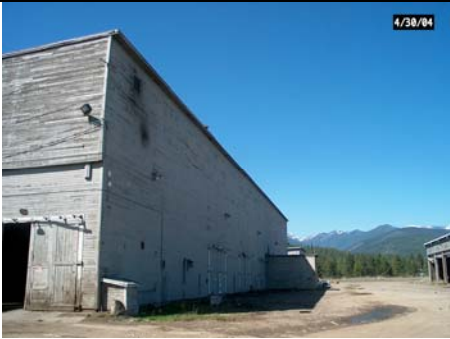
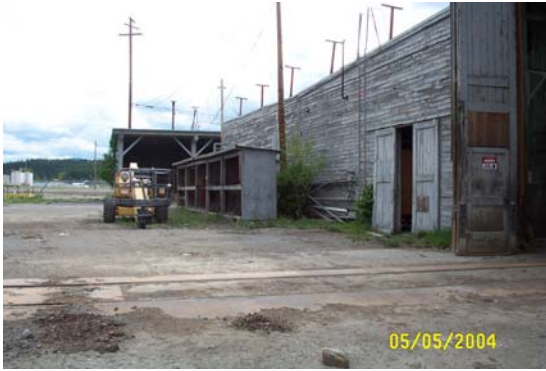
North side of Former Mobile Shop facing west, from the east end.	North side of Former Mobile Shop facing east, from the west end.	East side of Building, note the shed/shelves and pipe rack against the wall – the shed has no floor.

- Excavation along the perimeter of the building will not be required, as analytical results of soil samples taken in the perimeter areas reveal that LA asbestos is non-detect.
- However, surficial VCBM and VCI located on the top of the soil along the north and east sides of the building will be removed by vacuum methods, from the edge of the walls and outward approximately 45 feet.
- Items located within the work area, such as the racks and shelving will be left in place and protected during surficial removal.

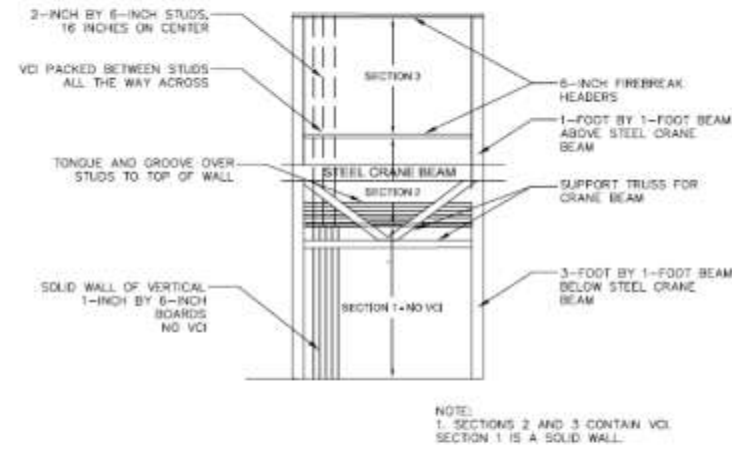
TYPICAL NORTH WALL BAY DETAIL WITHOUT DOORS

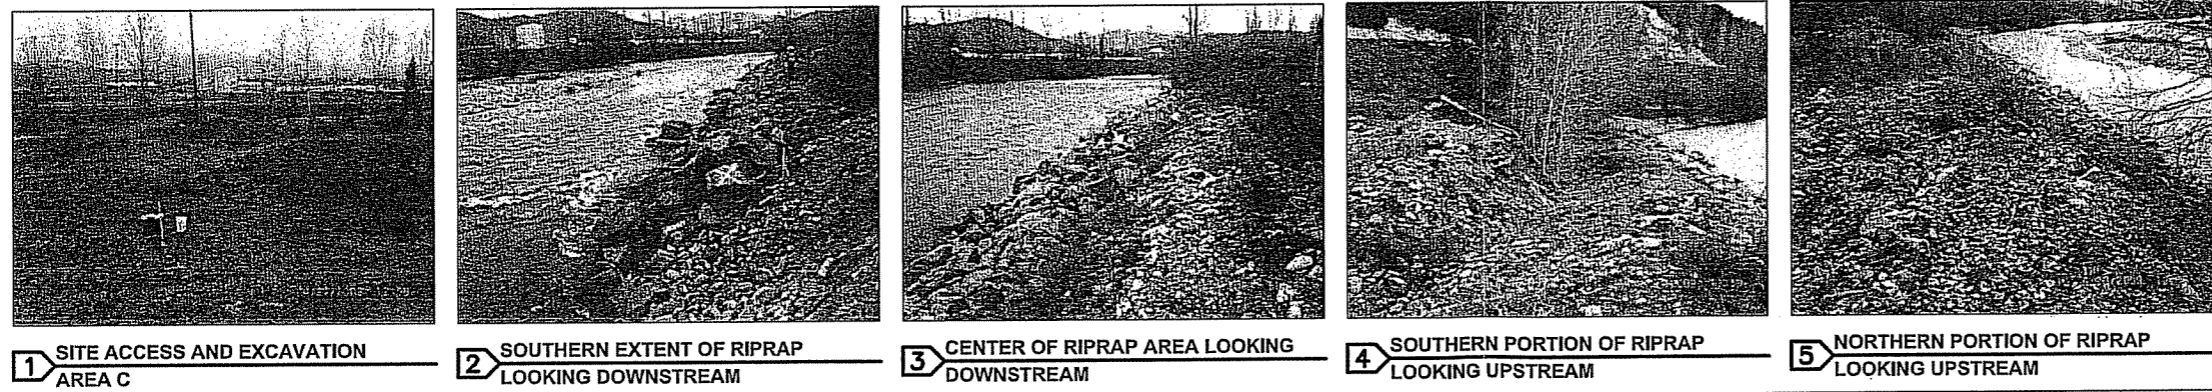
1 SITE ACCESS AND EXCAVATION AREA C    2 SOUTHERN EXTENT OF RIPRAP LOOKING DOWNSTREAM    3 CENTER OF RIPRAP AREA LOOKING DOWNSTREAM    4 SOUTHERN PORTION OF RIPRAP LOOKING UPSTREAM    5 NORTHERN PORTION OF RIPRAP LOOKING UPSTREAM
